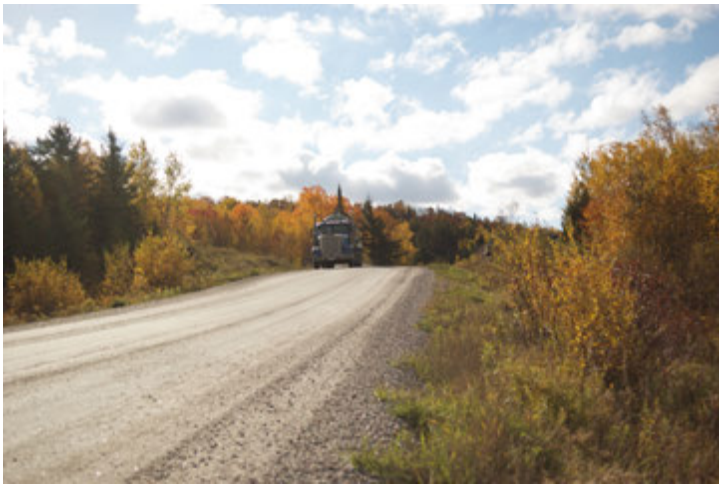
Image 1: Traveling southbound from Hwy 64. Truck is cresting the hill.

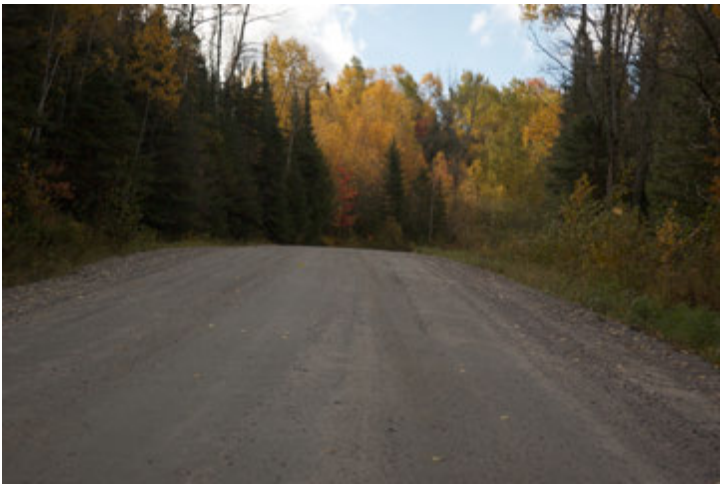
Image 2: Traveling southbound uphill, continues uphill and curves to the right.

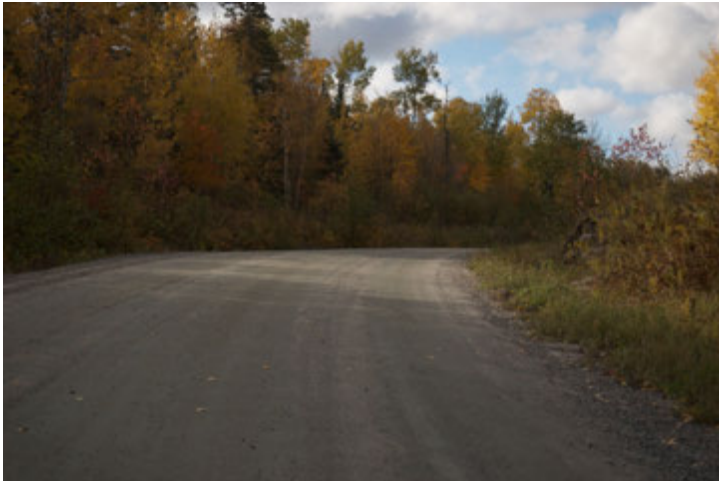
Image 3: Traveling southbound uphill, curves sharply to the right.

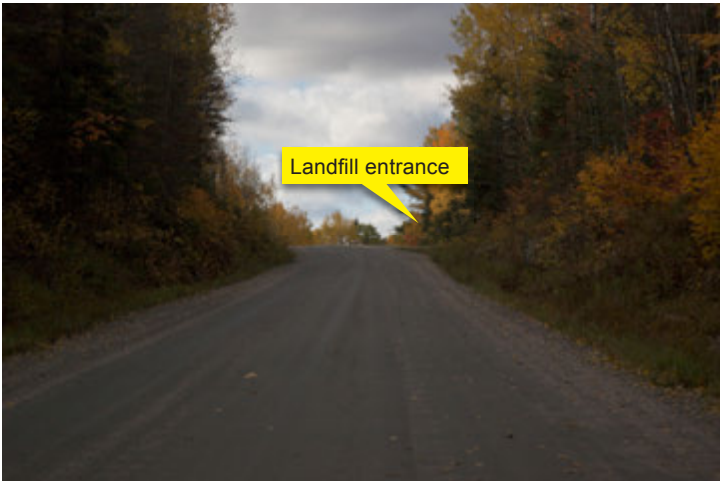
Image 4: Traveling southbound uphill, entrance of landfill to the right on crest of hill.

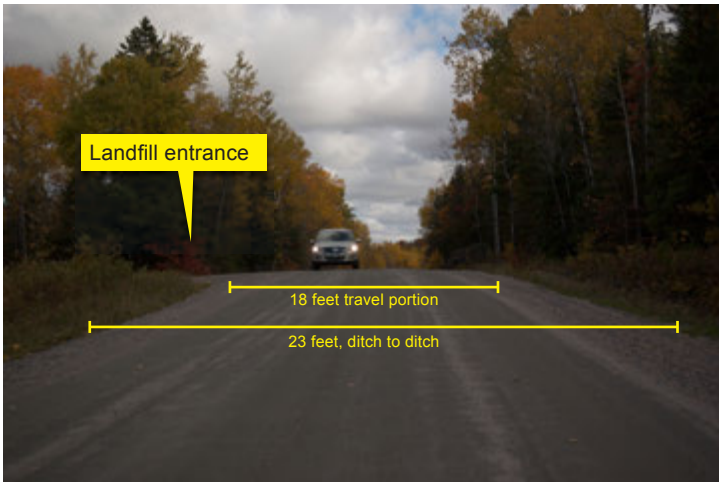
Image 5: View northward uphill, entrance of landfill to the left.

23ft ditch to ditch - 18ft travel portion

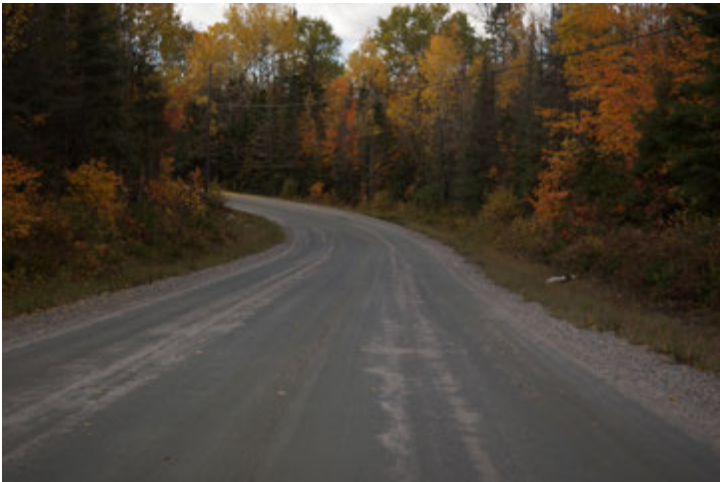
Image 6: Traveling southbound, steep downhill, just after landfill entrance, sharp curve to the left.

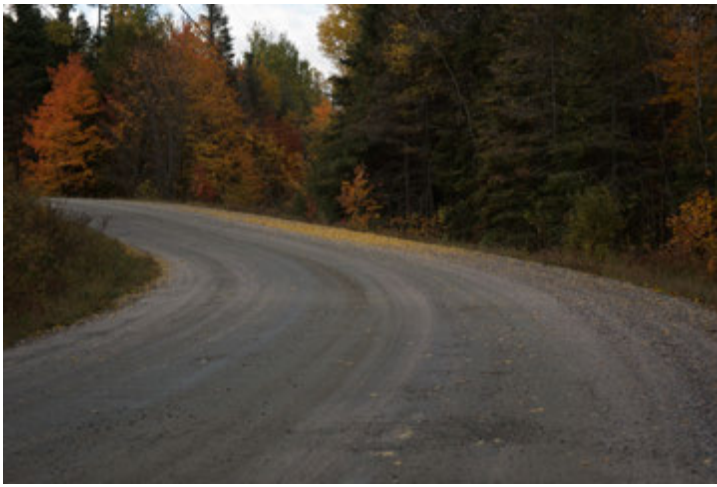
Image 7: Traveling southbound, continuing sharp curve to the left seen in image 6.

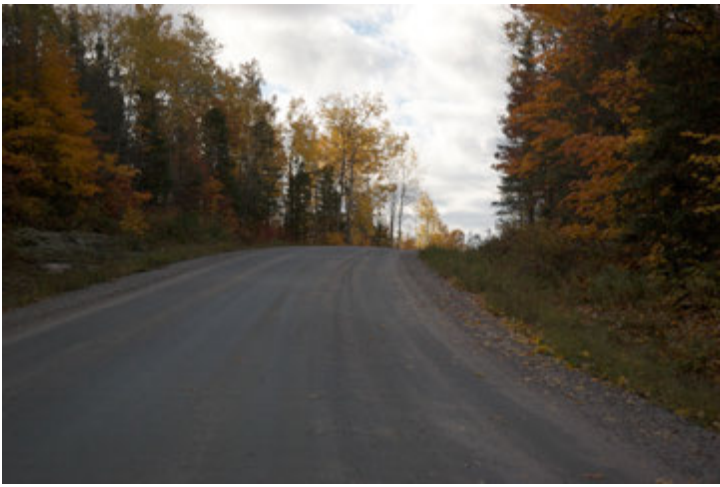
Image 8: Traveling southbound, after sharp curve to the left hill crest just ahead and veers right

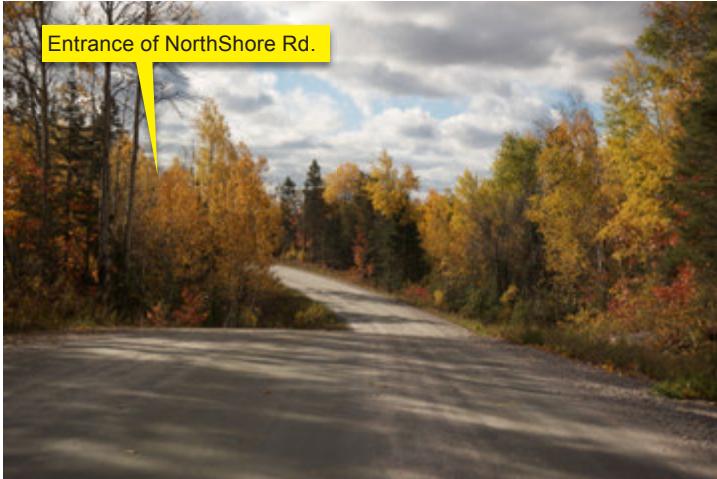
Image 9: Traveling southbound, on crest of hill steep hill veering left toward entrance of NorthShore Rd on the right.

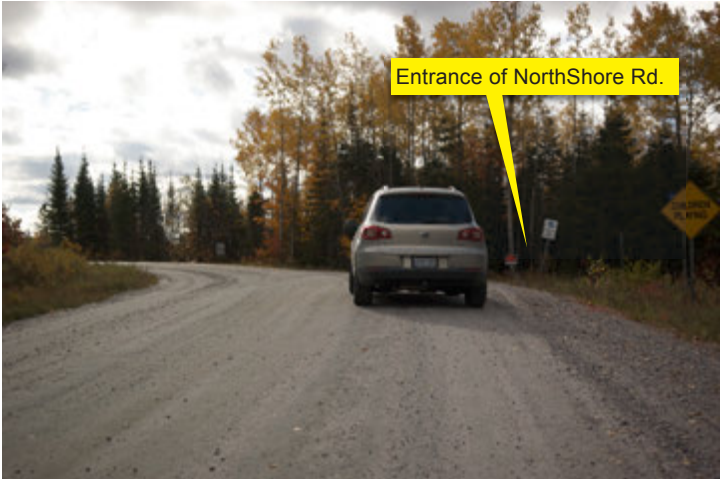
Image 10: Traveling southbound, entrance of NorthShore Rd on the right. Road curves to the left.

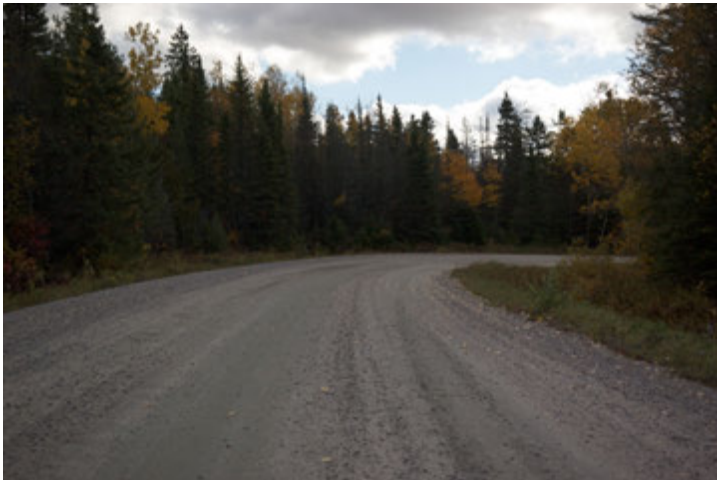
Image 11: Traveling southbound, toward entrance of West Nipissing public beach.

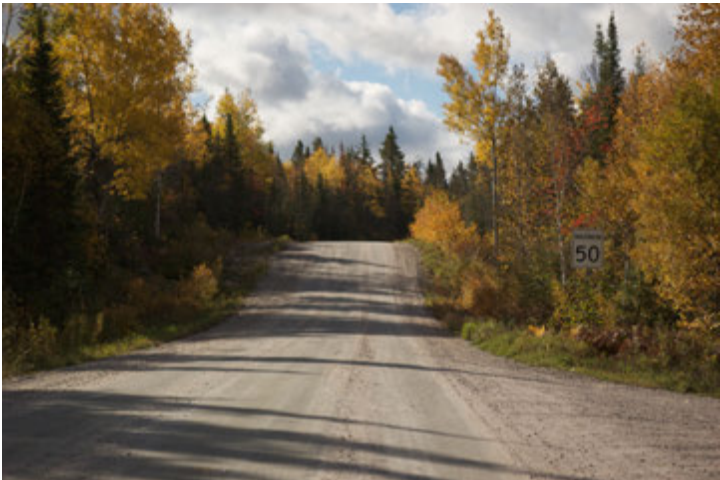
Image 12: Traveling southbound, entrance of West Nipissing public beach on right. Short steep hill ahead veers right.

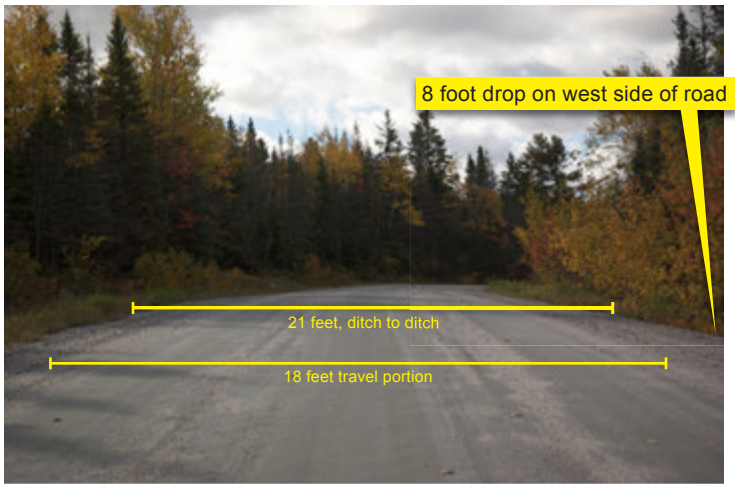
Image 13: Traveling southbound, on crest of hill seen in image 12. Curves to the right towards numerous residential driveways.

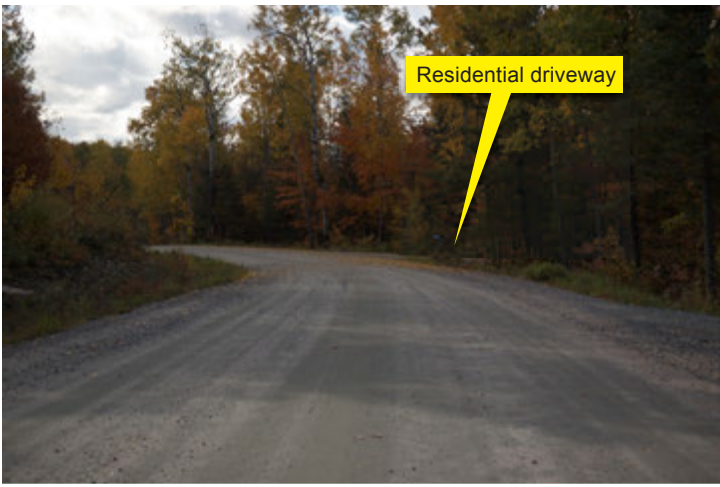
Image 14: Traveling southbound, curves sharp to the left at residential driveway.

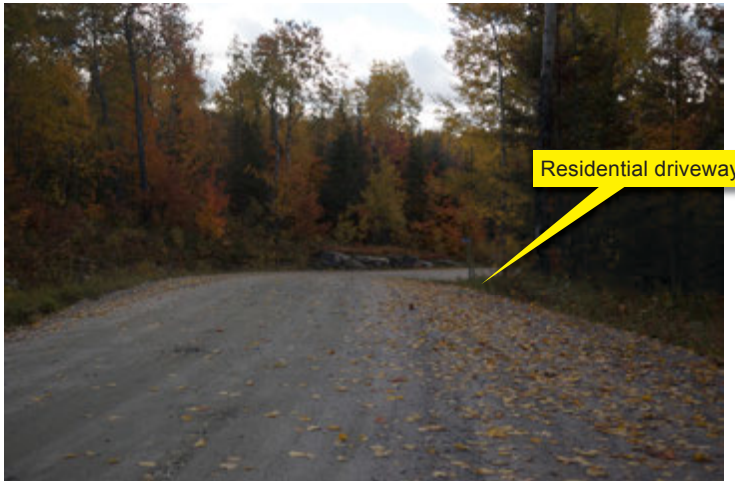
Image 15: Traveling southbound, downhill, curves sharp to the right at residential driveway.

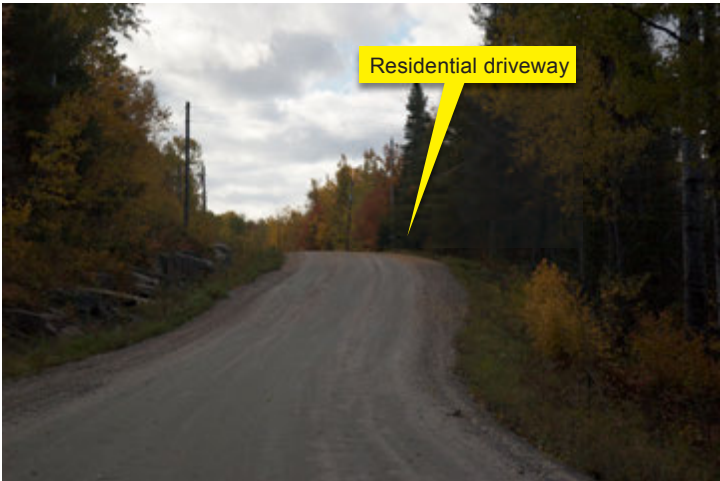
Image 16: Traveling southbound, uphill, curves sharp to the left at residential driveway.

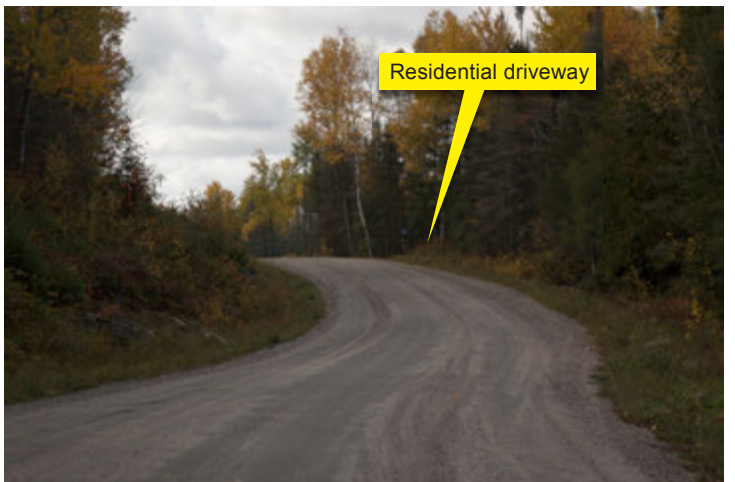
Image 17: Traveling southbound, hill curves sharp to the left at residential driveway.

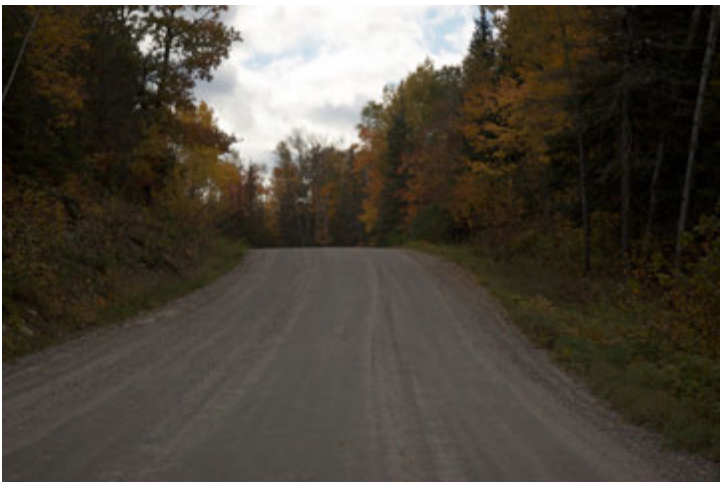
Image 18: Traveling southbound, hill crests with sharp curve to the left. Beginning of 60 km zone.

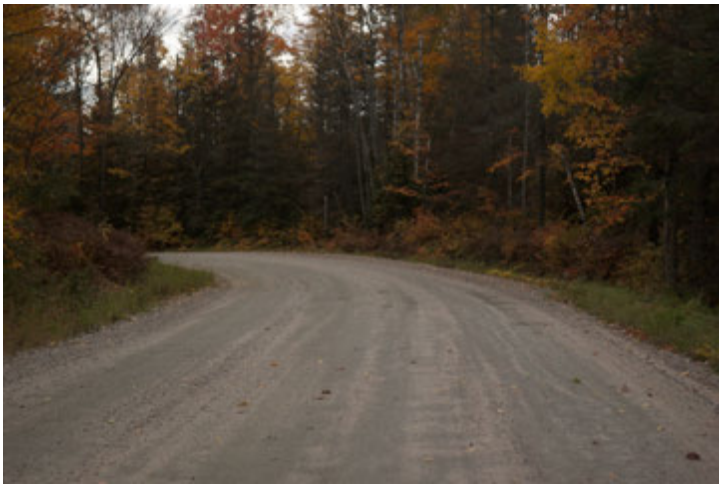
Image 19: Traveling southbound, on hill crest seen in image 18 with sharper curve to the left.

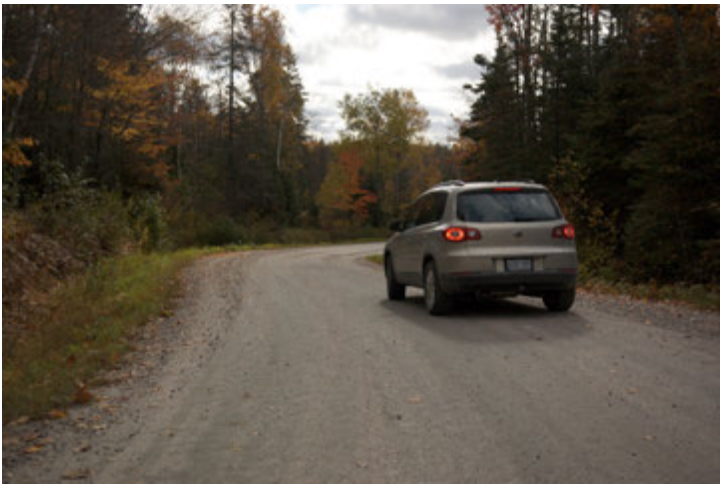
Image 20: Traveling southbound, downhill, just beyond sharp curve seen in image 19, towards very sharp corner to the right.

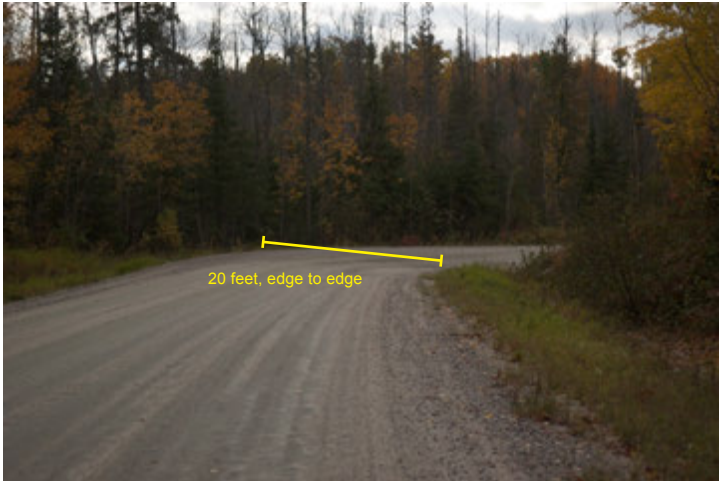
Image 21: Traveling southbound, downhill, towards very sharp corner to the right seen in image 20.

Dip to curve 20 foot edge to edge - many problems here in winter.

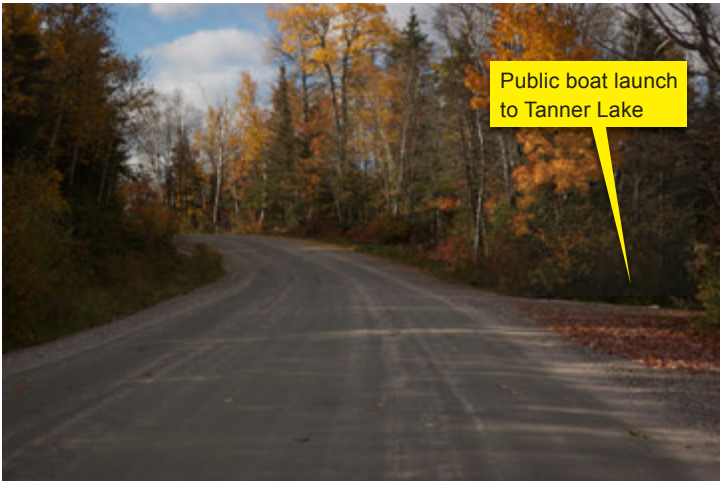
Image 22a: Traveling southbound. Road curves uphill to left just beyond public access point to Tanner Lake.

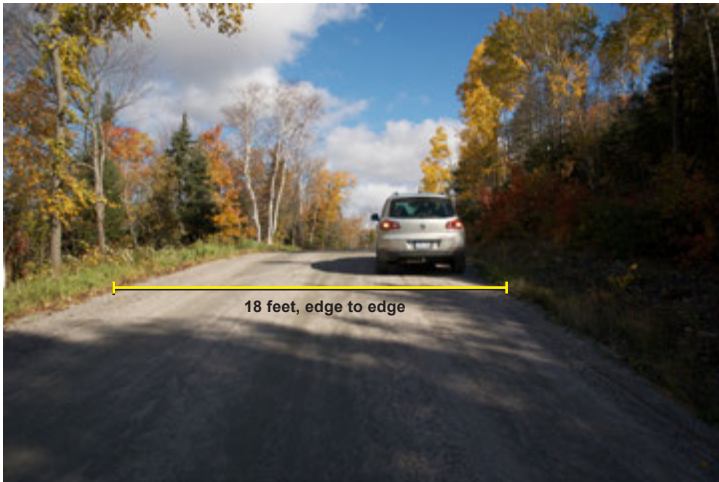
Image 22b: Facing northbound towards public access point to Tanner Lake, crest of hill, road is 18 feet wide, edge to edge.

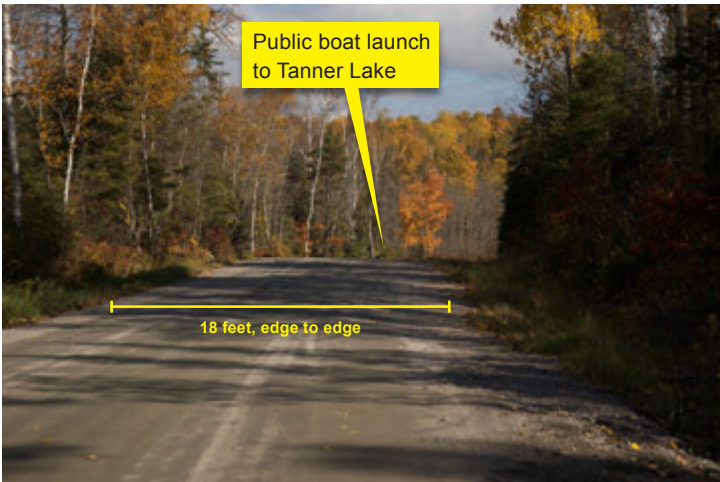
Image 22c: Facing northbound towards public access point to Tanner Lake, crest of hill, road is 18 feet wide, edge to edge.

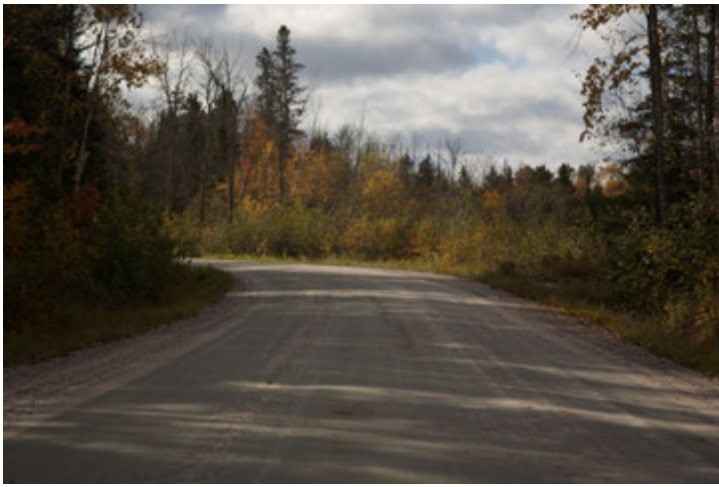
Image 23: Traveling southbound. Just south of public access point to Tanner Lake. Road curves sharp to left.

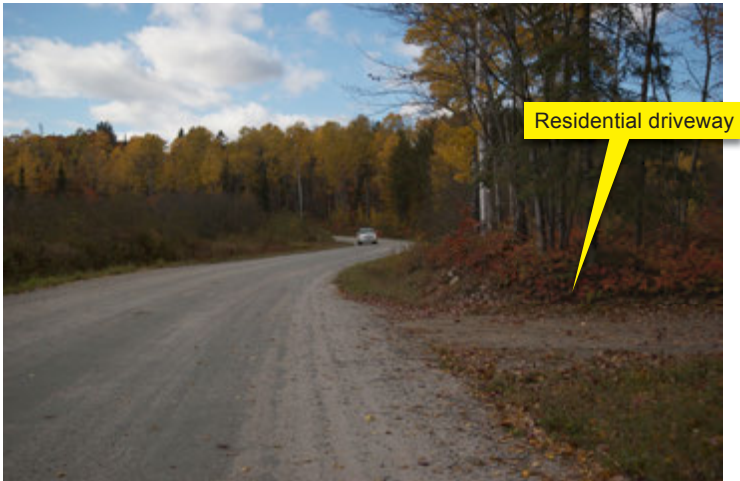
Image 25: Traveling southbound towards very sharp corner to the left.

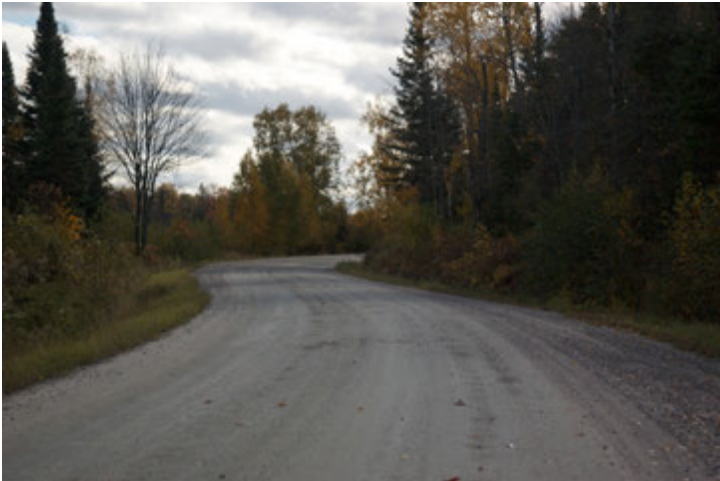
Image 26: Traveling southbound towards entrance of Denmar pit. Long sharp corner to right.

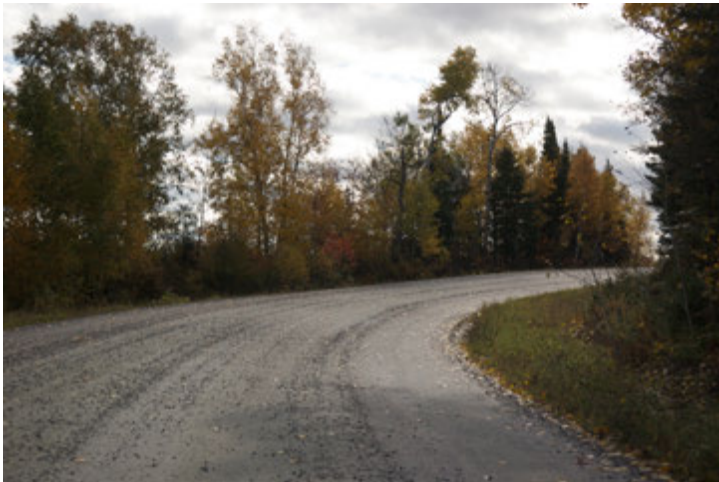
Image 27: Traveling southbound towards entrance of Denmar pit - in long sharp corner to right seen in image 26.

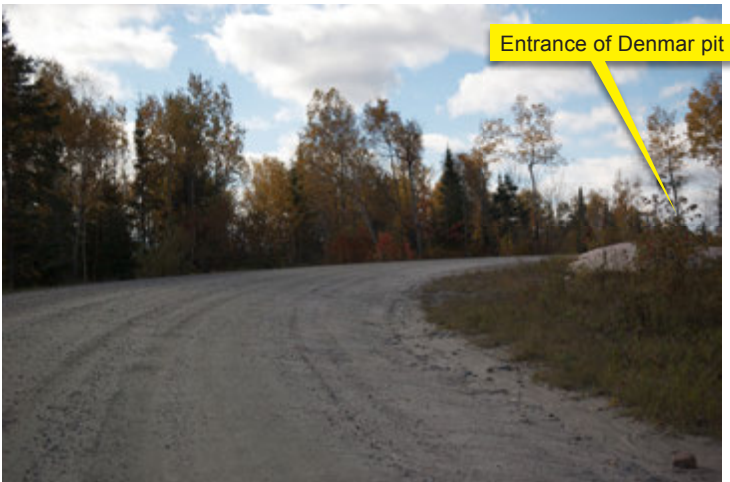
Image 28: Traveling southbound towards entrance of Denmar pit - still in long sharp corner to right seen in image 26 - 27.

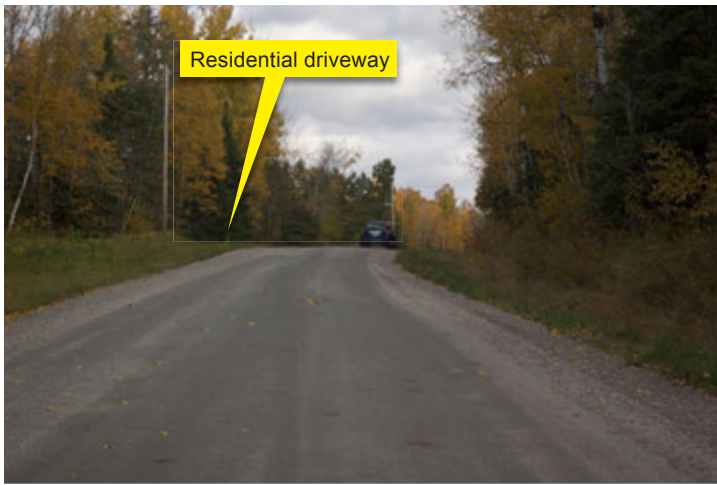
Image 29: **Now traveling northbound from Hwy 17**, uphill, curves to right at residential driveway on left at crest of hill.

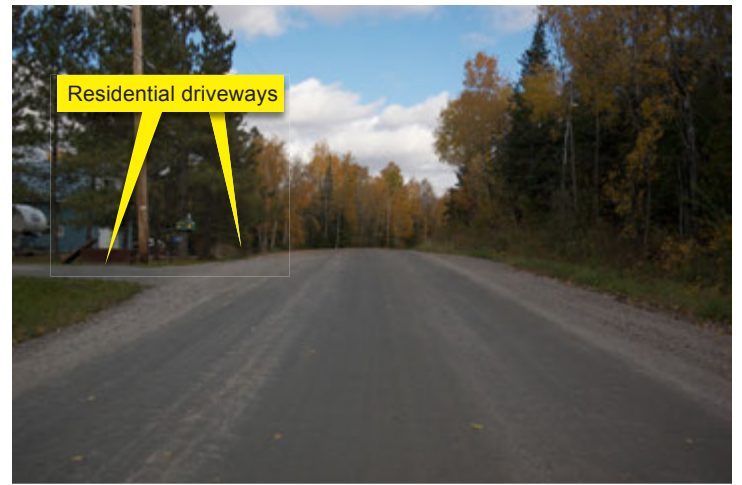
Image 30: Traveling northbound nearing crest of hill seen in image 29.

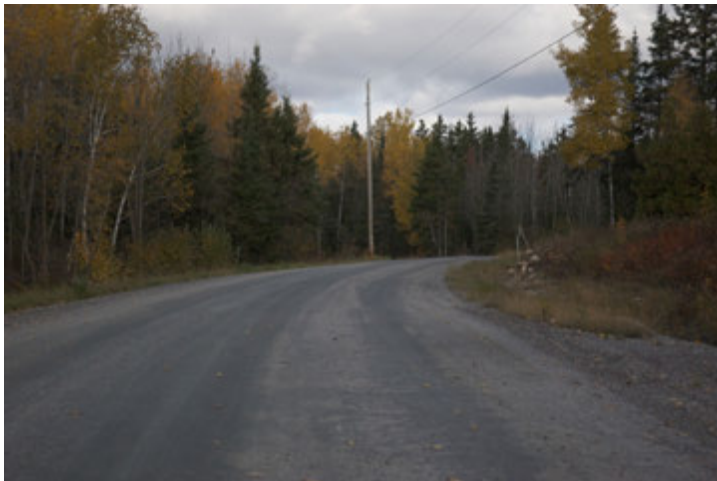
Image 31: Traveling northbound, snakes to the right then quickly left.

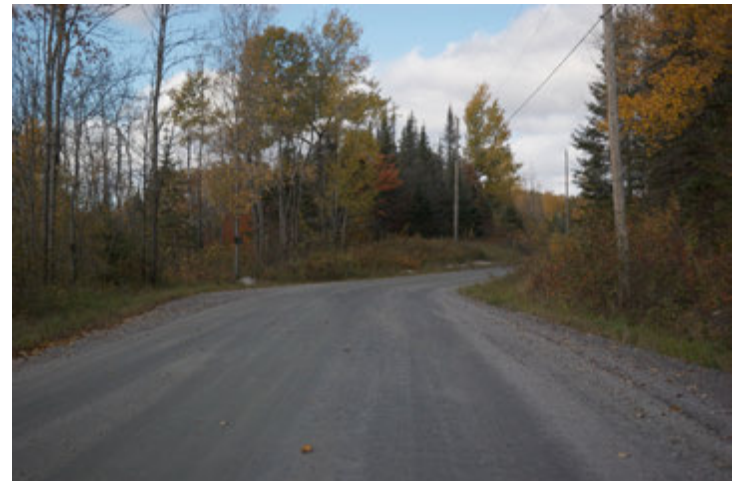
Image 32: Traveling northbound, sharp to the right.

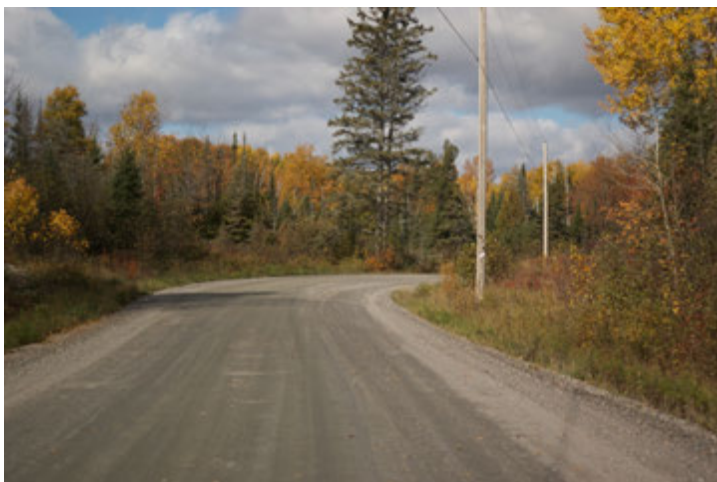
Image 33: Traveling northbound, sharp to the right.

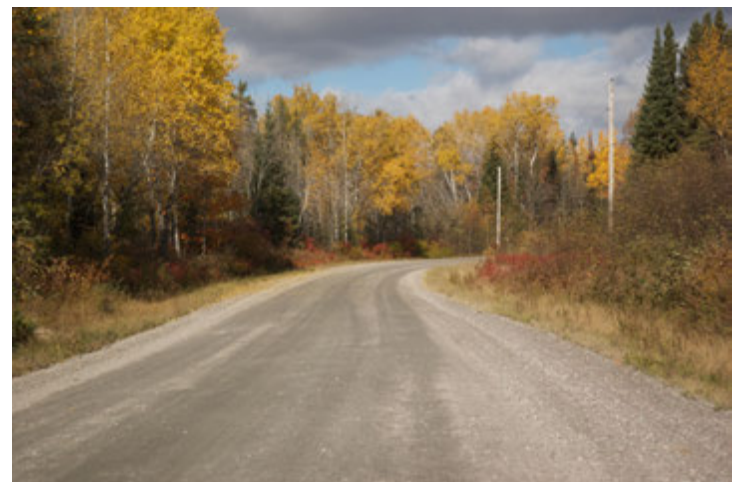
Image 34: Traveling northbound, sharp to the right, towards Lafond Rd. and West Nipissing Rod and Gun club entrance.

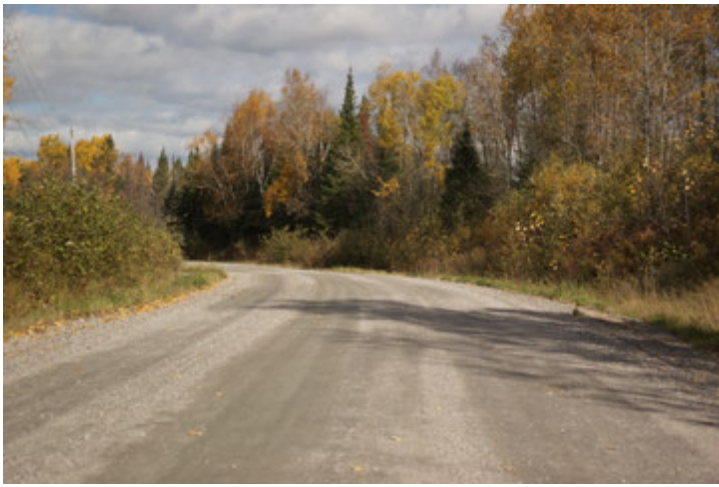
Image 35: Traveling northbound, long curve to the left.

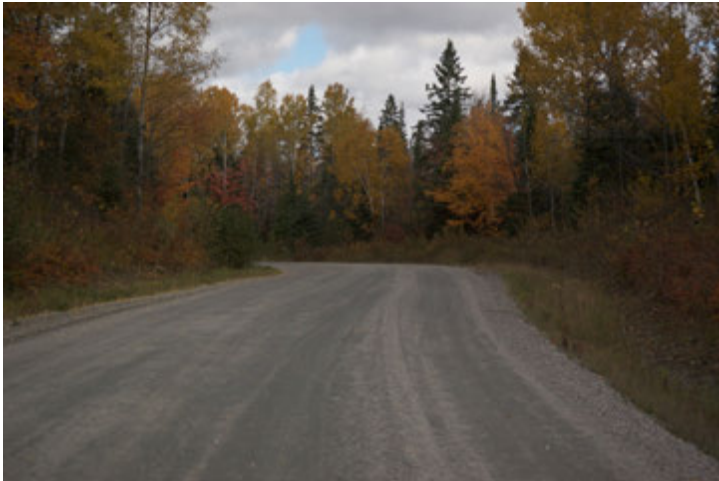
Image 37: Traveling northbound. Sharp curve to left.

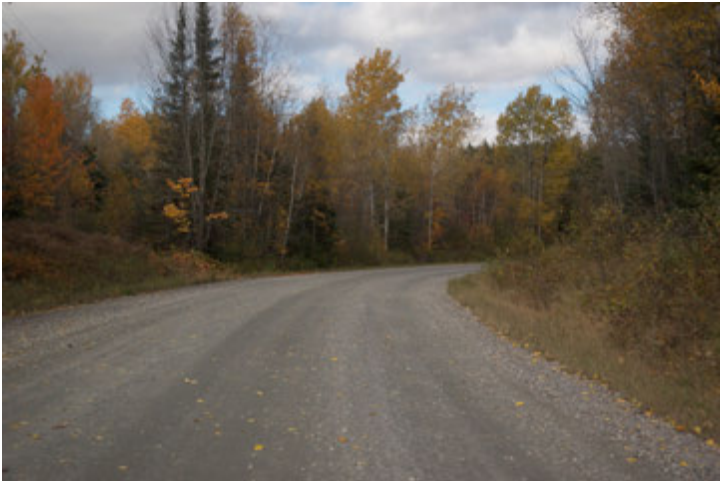
Image 38: Traveling northbound. Curve to right towards residential driveway.

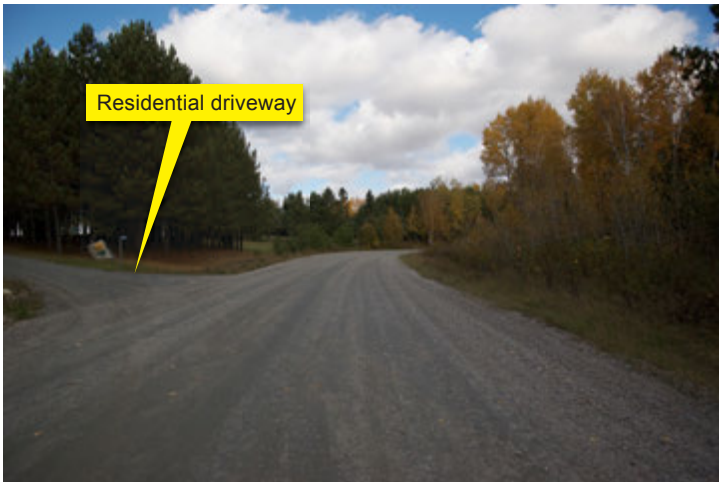
Image 39: Traveling northbound. Sharp right just beyond residential driveway.

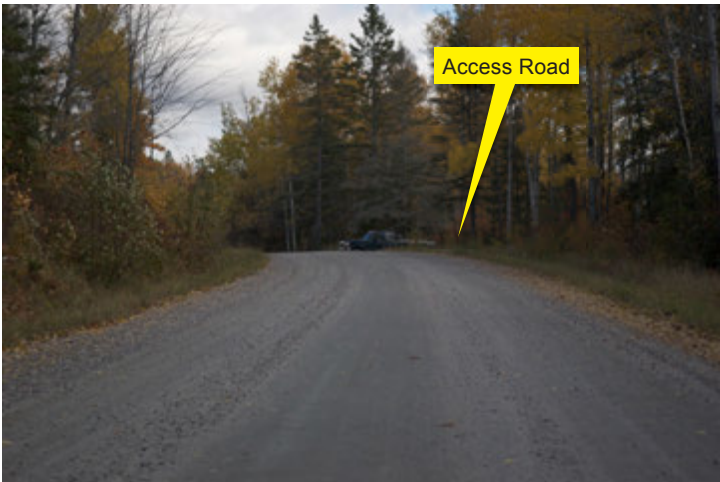
Image 40: Traveling northbound, uphill, curves left just beyond access road.

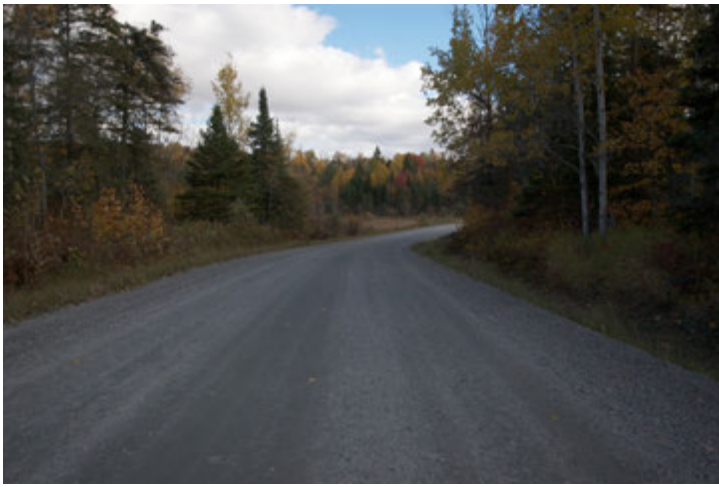
Image 41: Traveling northbound, downhill, curves sharp right.

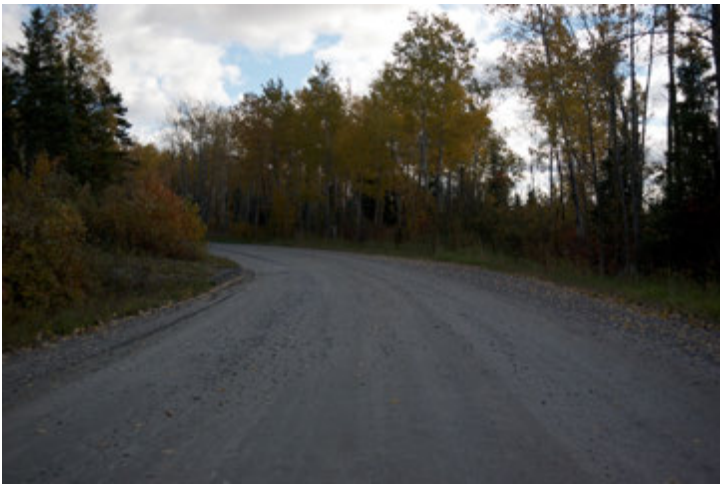
Image 42: Traveling northbound, curves sharp left, just south of Denmark pit main entrance.

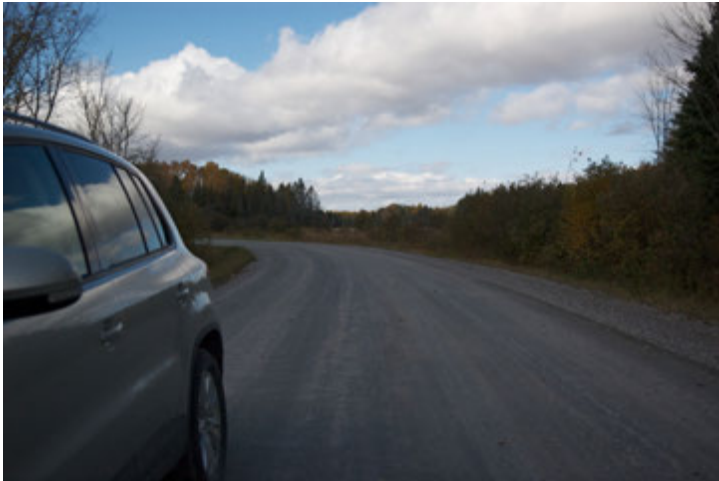
Image 43: Traveling northbound, looking south at sharp left seen in image 42, just south of Denmark pit main entrance.

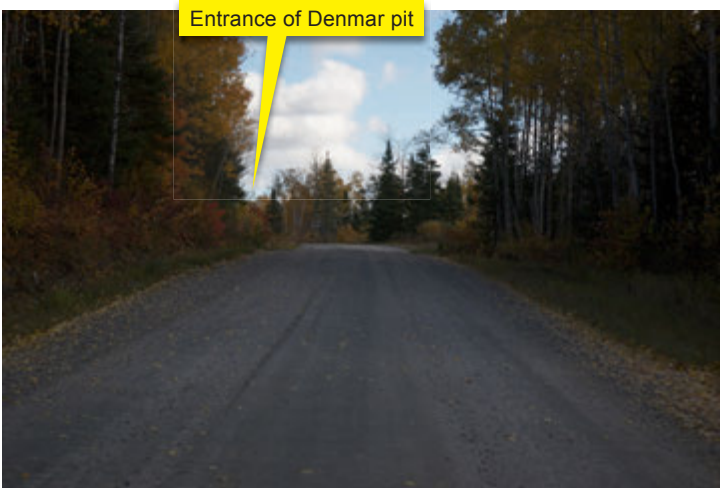
Image 44: Looking northbound, uphill, at the same spot seen in image 43, just south of Denmark pit main entrance.

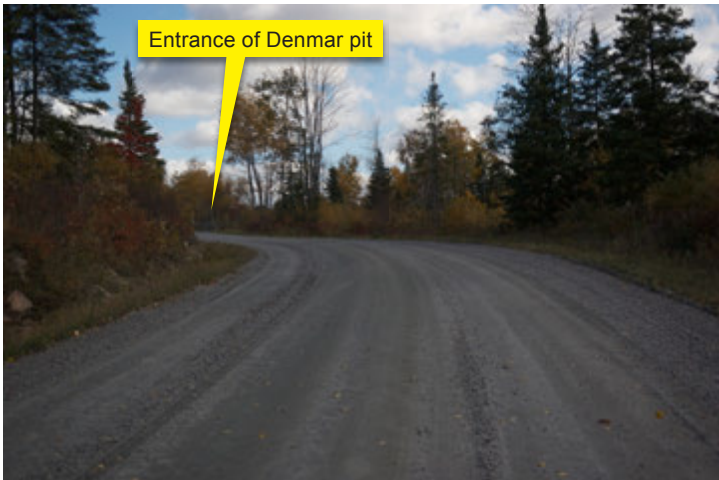
Image 45: Traveling northbound, uphill, sharp left, at main entrance of Denmark pit.

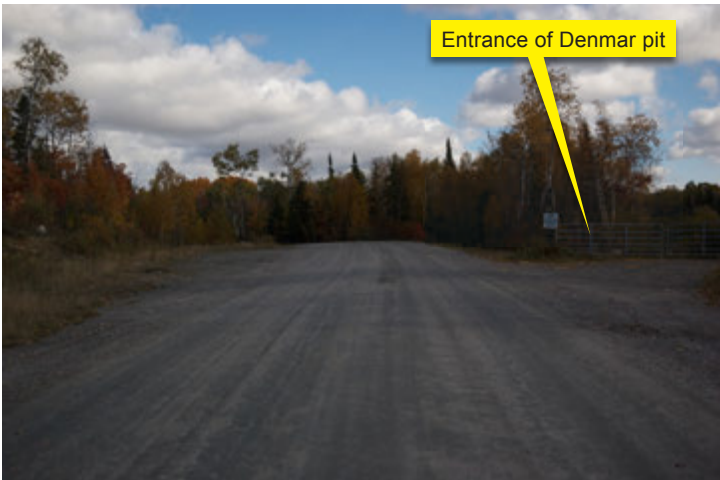
Image 46: Traveling northbound, at main entrance of Denmark pit. Road continues northward toward long sharp corner to the left, seen in images 26 - 28.
